Site Name: Crude Oil Spill Site
Location: Mayflower, Arkansas
Type of Site: Marsh environment
Contaminants of Concern: Crude oil–related sheens
Remedy: Reactive cap and in situ amendment placement
Current Site Status: Closed

Case Study Objectives: Present the basis of design and implementation approach for the mitigation action at the site affected by a crude oil release.

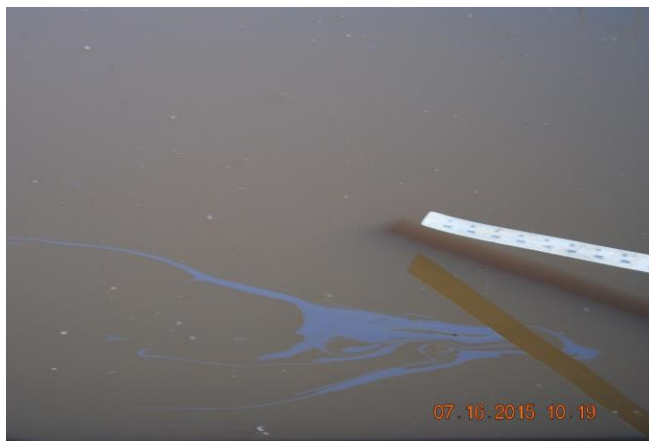
A sheen monitoring and sampling program was initiated in October 2013 to evaluate the presence of surface water sheens resulting from the low levels of residual crude oil in sediments within the cove. Based on the data evaluation, the limited areas with crude oil–related sheens appeared to be primarily located in the Inlet Channel and the Open Water Area. A predesign field study was completed at the site between March and April 2014 to confirm and refine the mitigation areas. The field study included sediment probing followed by sheen stir testing on sediment core samples to evaluate the horizontal and vertical extent of sheen-bearing material in the Inlet Channel, Open Water Area, and Heavily Vegetated Area.

Typical crude oil-related sheen patch/streamer observed at the site.

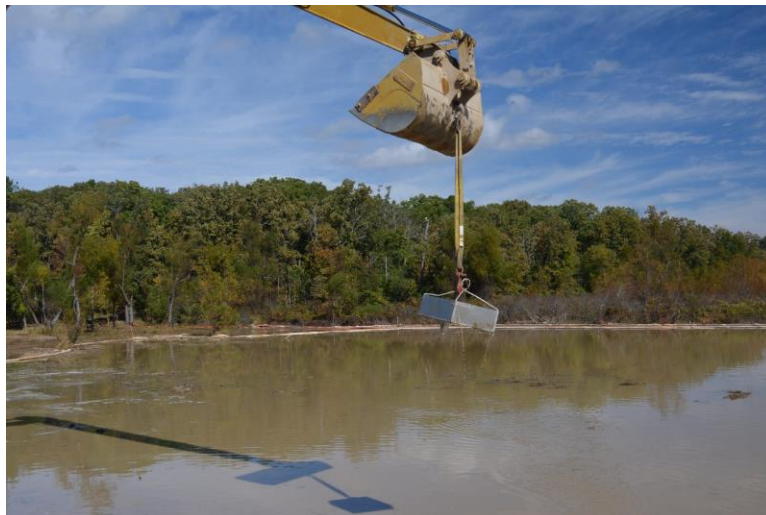
Placement of test catch pan in the Open Water Area.

- Reactive capping: The reactive cap material placed in the Open Water Area consisted of a sand/organoclay layer of approximately 3 to 7 inches, with an average thickness of 3.6 inches. The reactive cap material was mixed using an open-top concrete mixing hopper placed at the staging area. The reactive cap material was placed directly on the sediment surface using an amphibious long-reach excavator equipped with a global positioning system to achieve uniform distribution of cap material. Layer thickness verification was completed using catch pans.

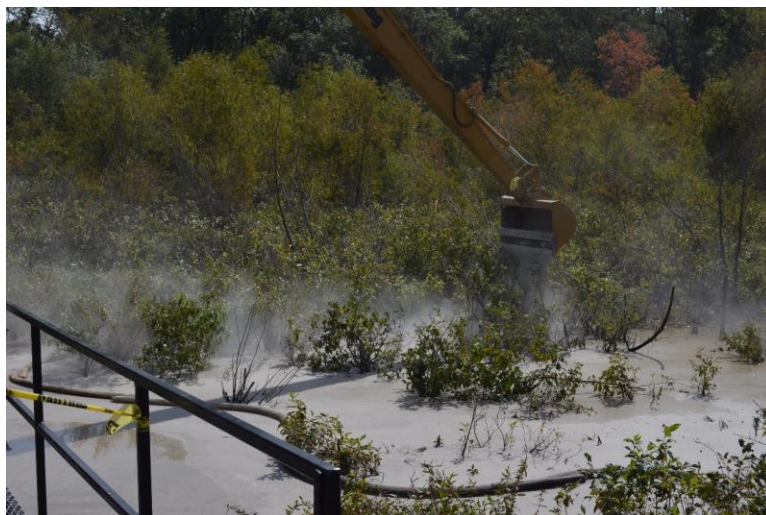
Amendment placement in the Heavily Vegetated Area.

- In situ amendment placement: Approximately 47 tons of organoclay was placed using the amphibious excavator in the Heavily Vegetated Area. Organoclay was manually distributed from the airboat in two distinct small areas located near the banks. Amendment weight was verified to ensure that the application rate of 1 pound per square foot was achieved.
