**Site Name:** Crude Oil Spill Site  
**Location:** Mayflower, Arkansas  
**Type of Site:** Marsh environment  
**Contaminants of Concern:** Crude oil–related sheens  
**Remedy:** Reactive cap and in situ amendment placement  
**Current Site Status:** Closed

**Case Study Objectives:** Present the basis of design and implementation approach for the mitigation action at the site affected by a crude oil release.

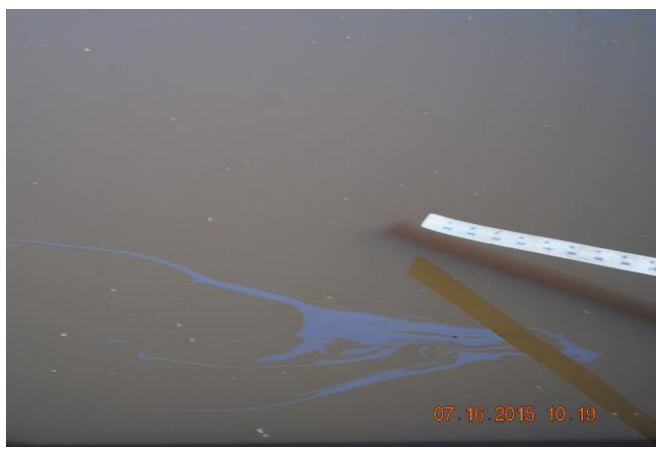
A sheen monitoring and sampling program was initiated in October 2013 to evaluate the presence of surface water sheens resulting from the low levels of residual crude oil in sediments within the cove. Based on the data evaluation, the limited areas with crude oil–related sheens appeared to be primarily located in the Inlet Channel and the Open Water Area. A predesign field study was completed at the site between March and April 2014 to confirm and refine the mitigation areas. The field study included sediment probing followed by sheen stir testing on sediment core samples to evaluate the horizontal and vertical extent of sheen-bearing material in the Inlet Channel, Open Water Area, and Heavily Vegetated Area.

Typical crude oil-related sheen patch/streamer observed at the site.

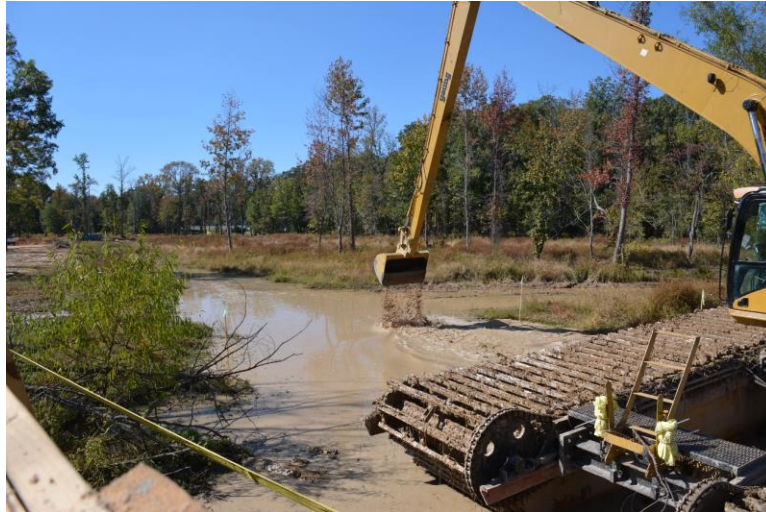
Reactive cap placement in the Open Water Area.

- Reactive capping: The reactive cap material placed in the Open Water Area consisted of a sand/organoclay layer of approximately 3 to 7 inches, with an average thickness of 3.6 inches. The reactive cap material was mixed using an open-top concrete mixing hopper placed at the staging area. The reactive cap material was placed directly on the sediment surface using an amphibious long-reach excavator equipped with a global positioning system to achieve uniform distribution of cap material. Layer thickness verification was completed using catch pans.

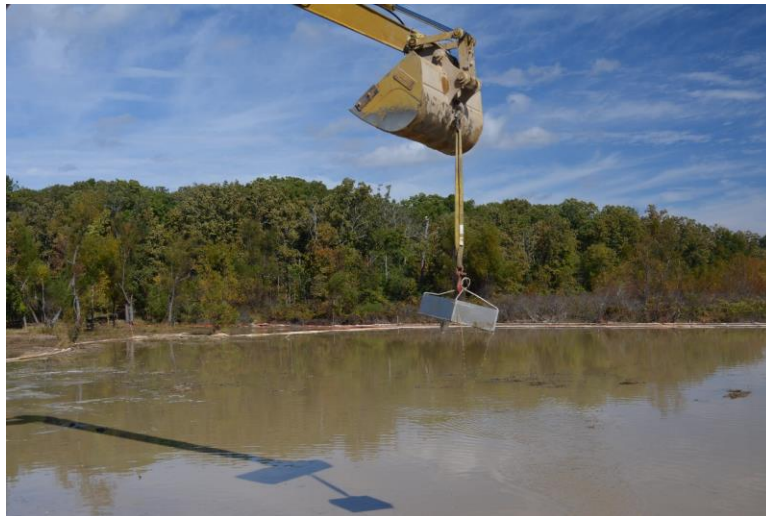
Placement of test catch pan in the Open Water Area.

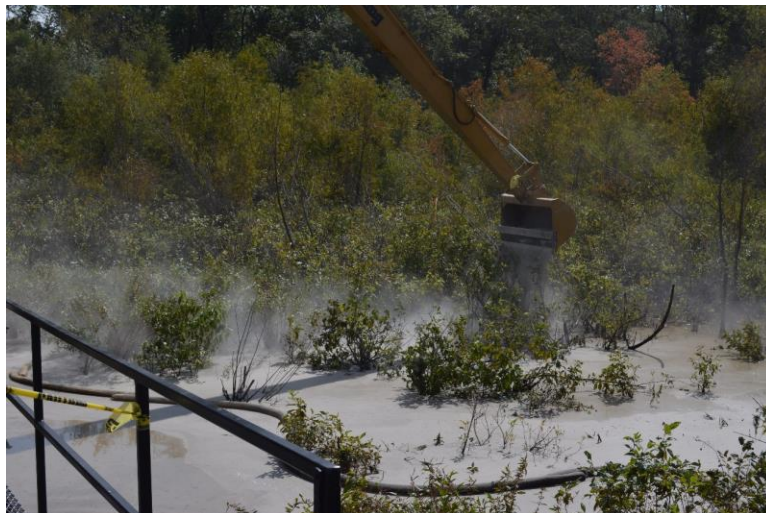
Amendment placement in the Heavily Vegetated Area.

- In situ amendment placement: Approximately 47 tons of organoclay was placed using the amphibious excavator in the Heavily Vegetated Area. Organoclay was manually distributed from the airboat in two distinct small areas located near the banks. Amendment weight was verified to ensure that the application rate of 1 pound per square foot was achieved.
