Site Name: Former Portland Gas Manufacturing Site

Type of Site: Former manufactured gas plant along river

Remedy: Dredging, amended capping, enhanced natural recovery, monitored natural recovery

Case Study Objectives: To provide an overview of the site and the capping element of the remedy. This case study focuses on aspects of the design, construction, and long-term monitoring program.

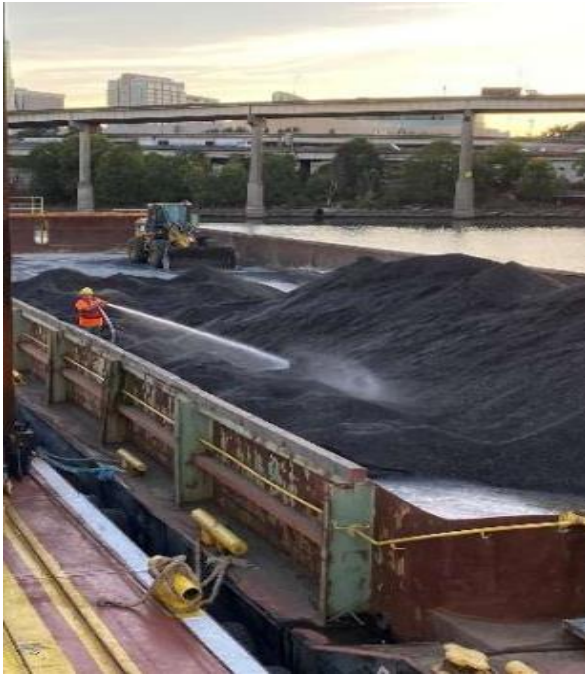
Cap material.

During construction, the GAC content was measured ex situ (prior to placement). Ex situ results showed that the cap material was super-amended, by design, at 10% GAC by weight. In total, 12 in situ samples of capping materials were tested to verify that the minimum GAC content was maintained during material placement. In situ GAC content was measured at contents ranging from 7.8% to 18.3% by weight (average of 11.7%). These results indicated that the as-built GAC content exceeded the design requirements and there was little or no loss of GAC during placement, which is largely attributed to strict GAC saturation protocols and submerged bucket placement techniques.

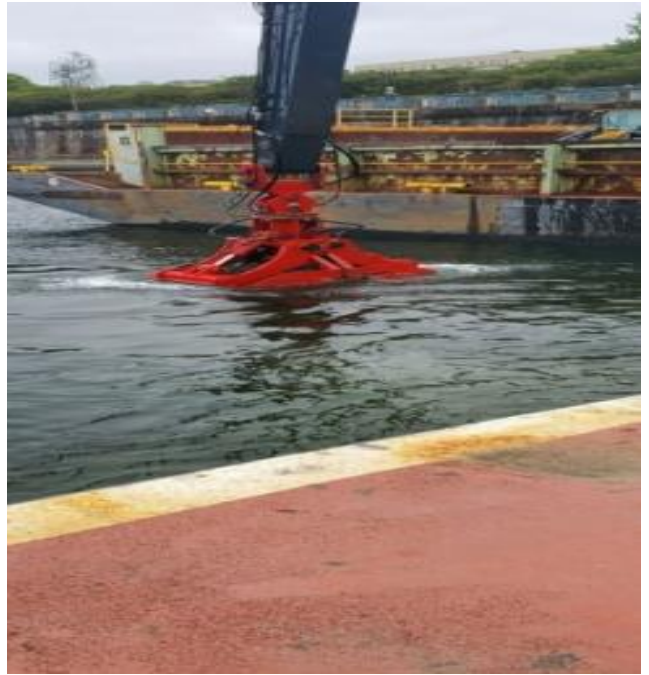
Cap material placement.

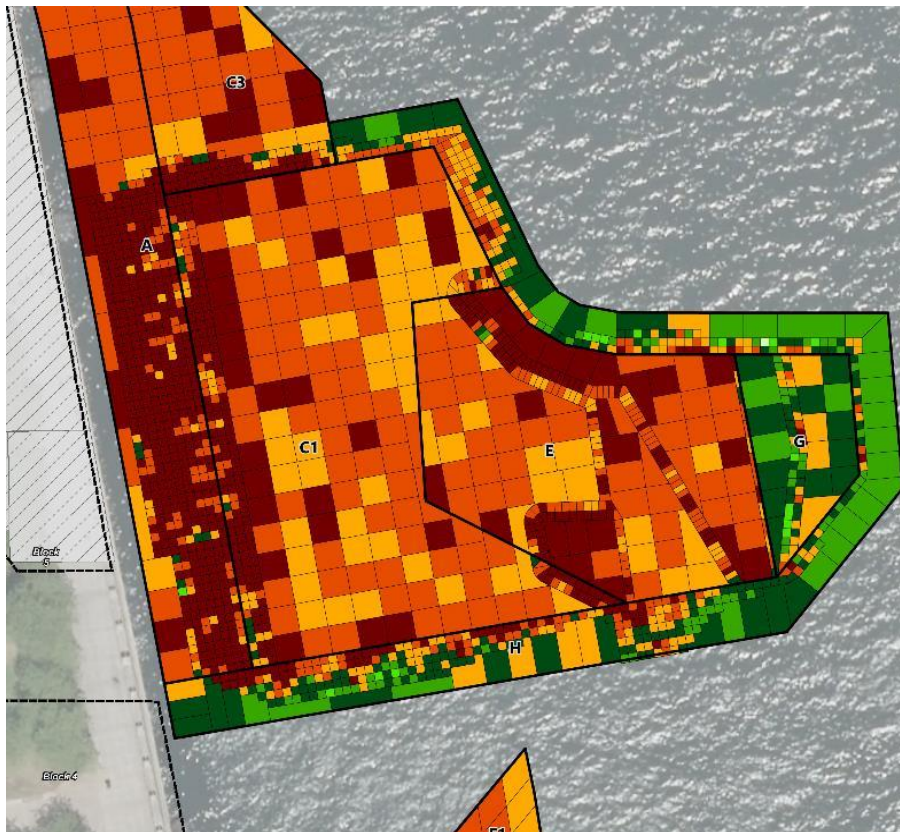
Cap thickness verification.

Cap Thickness in Inches

-   0.1 to 3
-   3.1 to 6
-   6.1 to 9
-   9.1 to 11.99
-   12.0 to 15
-   15.1 to 18
-   > 18

Construction monitoring results showed that all cap areas met their required 12-inch thicknesses and that some areas received 18 or more inches of cap materials. Cap thicknesses were verified by multibeam bathymetric progress and acceptance surveys. Catch pans were deployed to provide a second independent check to corroborate bathymetry survey results.

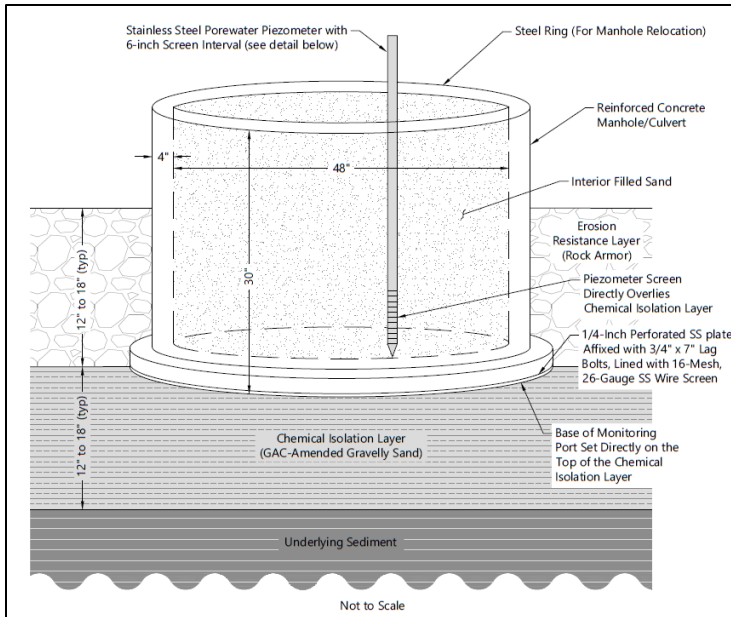
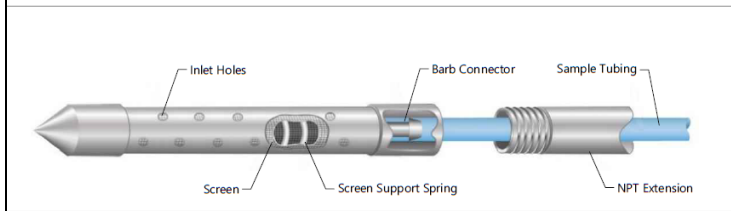
Stainless Steel Porewater Piezometer Detail.

Post-Remedy Monitoring: Record of Decision (ROD) cleanup levels for sediment, transition-zone water (porewater), and surface water apply to the project. Sediment cleanup levels for benthic toxicity will be evaluated on a point-by-point basis, whereas cleanup levels for bioaccumulation will be evaluated on a sitewide SWAC. A similar approach is used for assessing transition zone and surface water. Four manhole-type sampling ports with pre-installed piezometers were placed within the armored part of the cap to facilitate post-remedy porewater sampling.

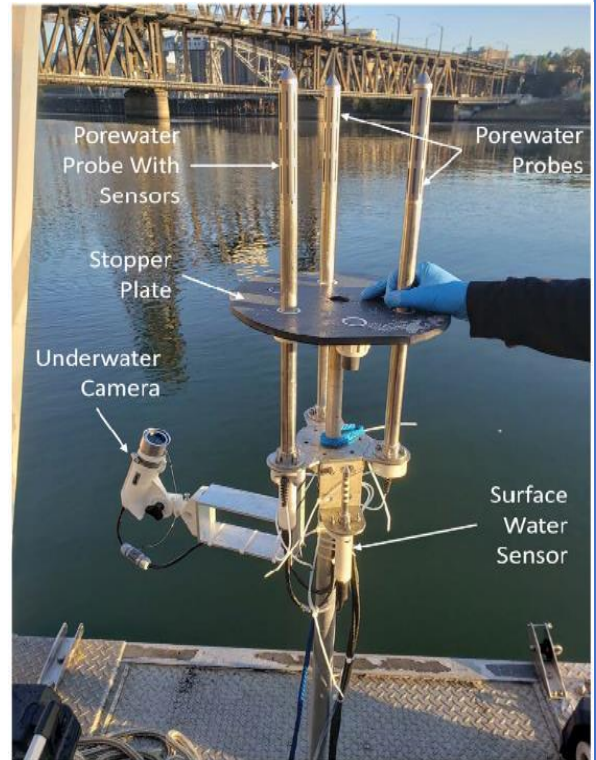
Sampling Port.

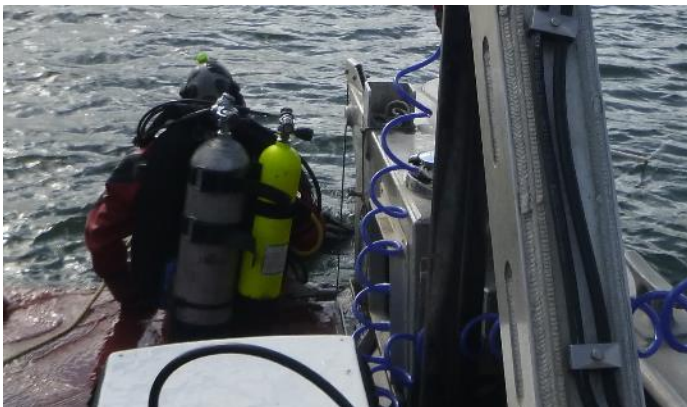
Diver Assistance during Sampling Port Installation.

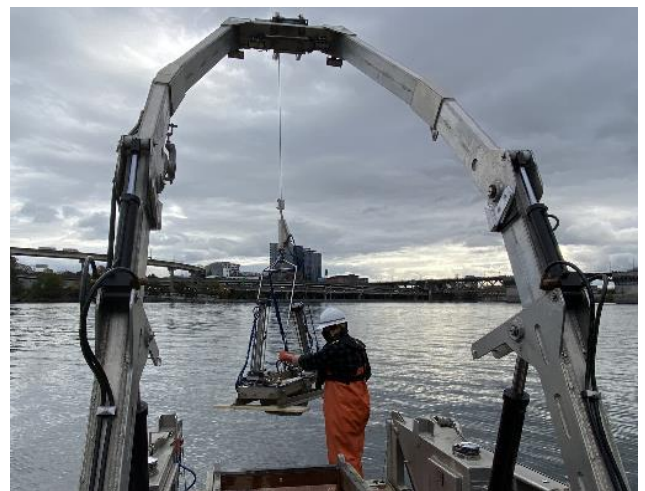
Sampling Port Installation.
